**FRONT SUSPENSION POPPING NOISE WHILE TURNING RIGHT OR LEFT—VEHICLES BUILT BEFORE 4/8/2005**

**TSB 05-9-11**

**FORD:**  
2005 Mustang

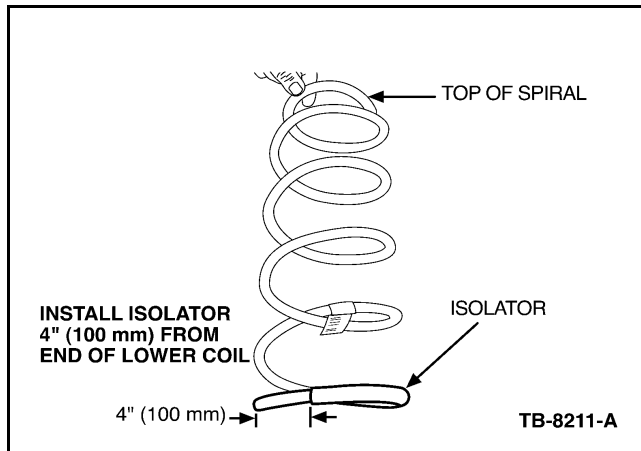
Figure 1 - Article 05-9-11

Some 2005 Mustang vehicles built before 4/8/2005 may exhibit an intermittent popping noise from the front of the vehicle while turning left or right. The noise will typically occur during low speed maneuvers and may occur multiple times while turning.

1. Remove the strut and spring assembly. Refer to Workshop Manual Section 204-01.
2. Disassemble the strut and spring assembly.
3. If the springs do not have a rubber isolator on the bottom spring coil, install isolators. Clean off any dirt prior to installing the isolator. The isolator should be installed 4" (100 mm) from the end of the coil (Figure 1).
