**FORD:**  
2005 Mustang

## TSB 05-17-14 (Continued)

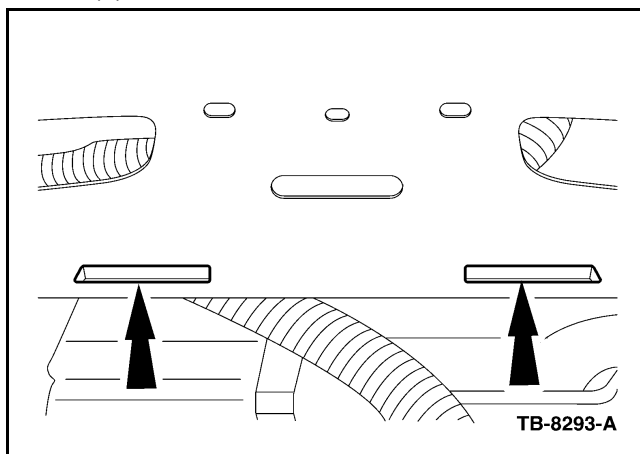
Figure 1 - Article 05-17-14

Some 2005 Mustang vehicles may exhibit the seat cushion cover front trim being loose on the front seat. The J-clip that holds the seat cushion cover trim to the front of the seat pan may not be fully engaging the flanges (slots) in the seat pan.

1. Remove the affected seat. Refer to Workshop Manual Section 501-10.
2. Pull back the seat cushion cover trim and foam to access the (4) flanges in the seat pan (Figure 1).
