## Interior - Front Seat Cushion Trim Loose

TSB 05-19-10

### LOOSE SEAT CUSHION COVER TRIM ON FRONT OF FRONT SEAT

FORD:  
2005 Mustang

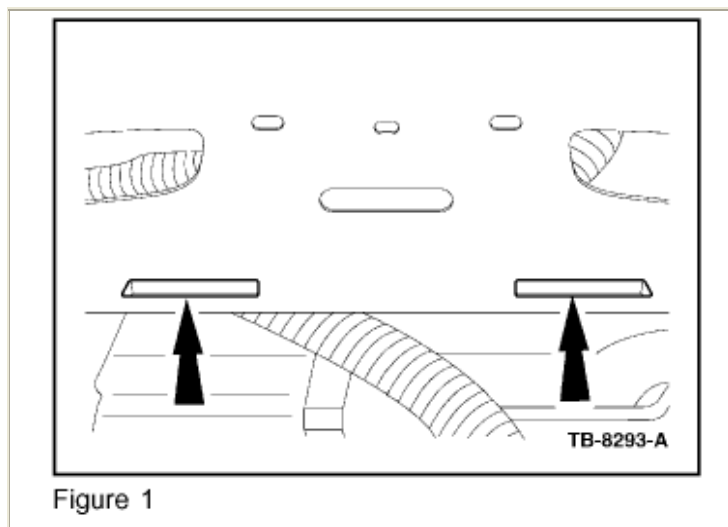
Figure 1

Some 2005 Mustangs built before 5/10/2005 may exhibit the seat cushion cover front trim being loose on the front seat. The J-clip that holds the seat cushion cover trim to the front of the seat pan may not be fully engaging the flanges (slots) in the seat pan.

1. Pull back the seat cushion cover trim and foam to access the (4) flanges in the seat pan (Figure 1).
