FORD:
2005-2006 Mustang

ISSUE

Some 2005/2006 Mustang Convertible vehicles may require a repair of the convertible top. Individual components should continue to be used where appropriate, but if required a new top assembly is now available.

TSB 05-24-6 (Continued)

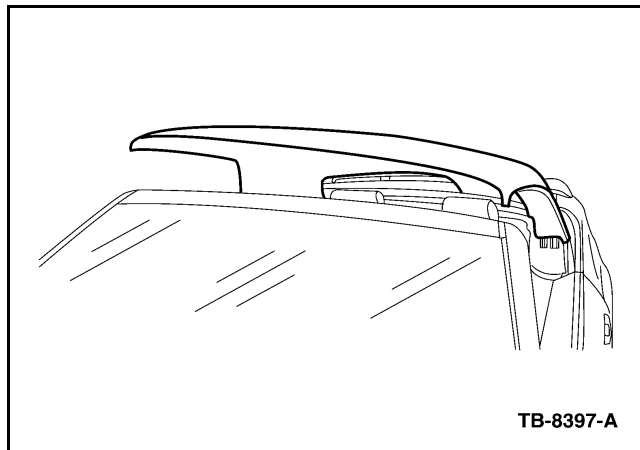
Figure 1 - Article 05-24-6

1. Top lifts unevenly side-to-side with no hydraulic system issues. (Figure 1)

Replace Side Rails:

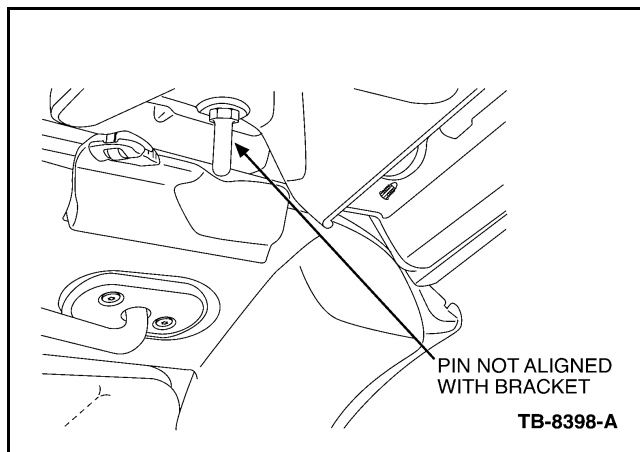
Figure 2 - Article 05-24-6

2. Top latch dowel pins do not align with header latch bracket. (Figure 2)

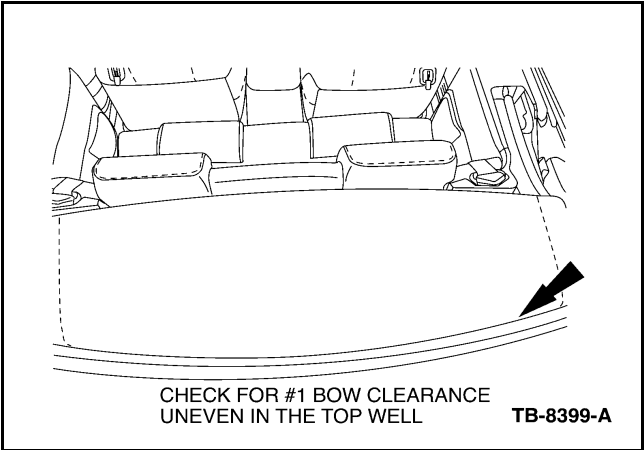
Figure 3 - Article 05-24-6

3. Top #1 bow clearance to top well in the body is uneven. (Figure 3)

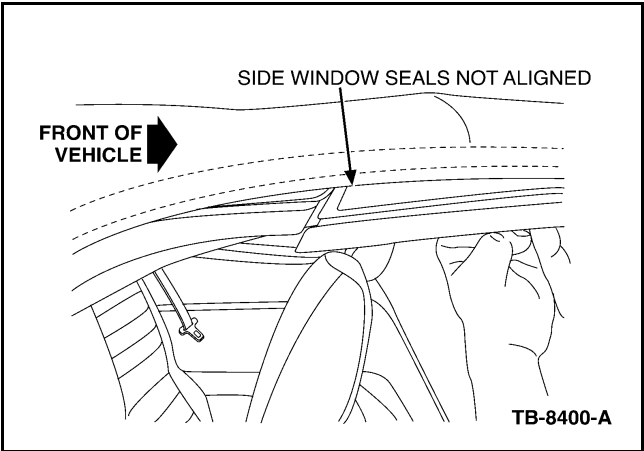
Figure 4 - Article 05-24-6

4. Side window seals do not align properly to side glass. (Figure 4)

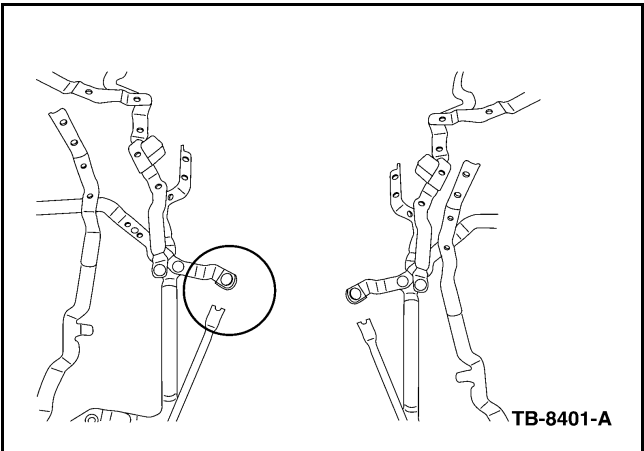
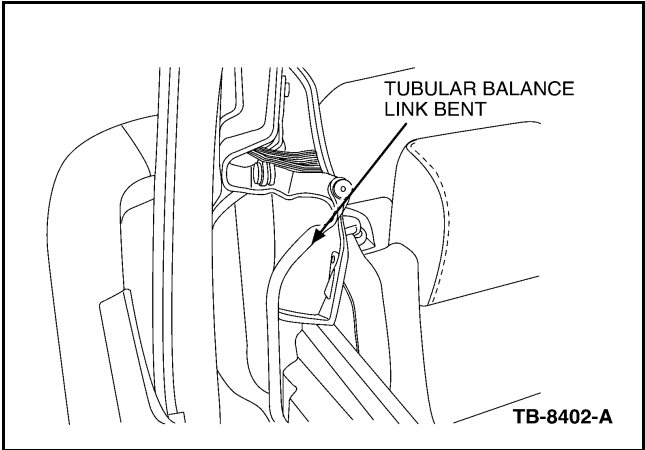
1. Side rail linkage broken. (Figures 5 and 6)

Replace Top Assembly:
