RATTLE/NOISE FROM THE CENTER STACK (RADIO/HEATER) OF THE INSTRUMENT PANEL OR GEARSHIFT AREA

TSB 06-4-1

FORD:
2005-2006 Mustang

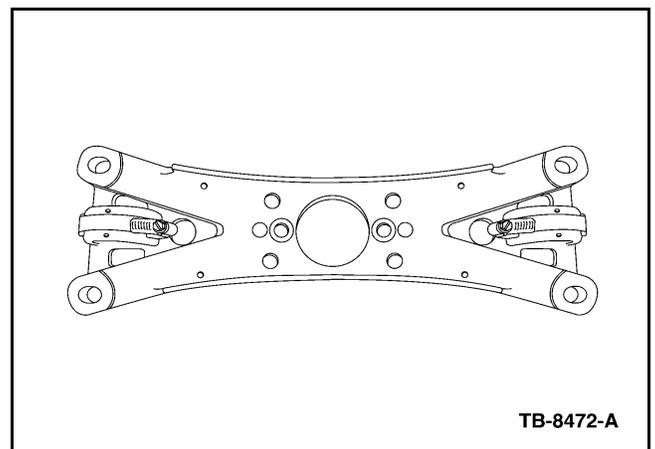
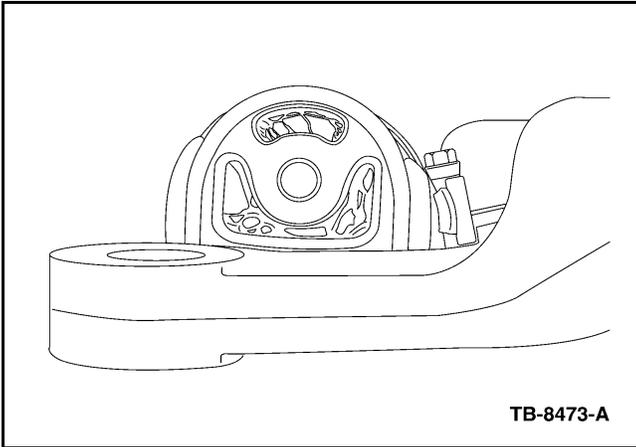
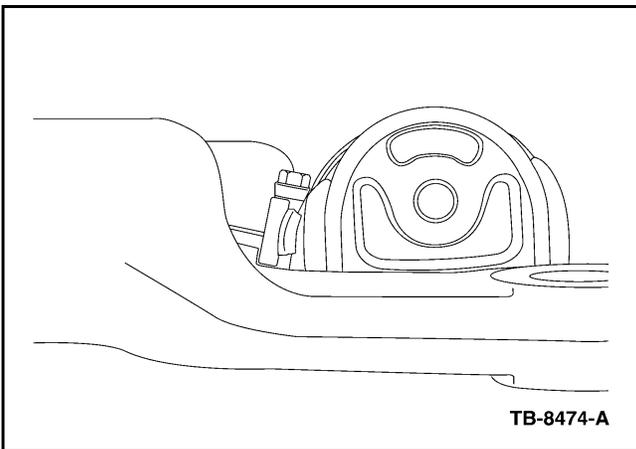
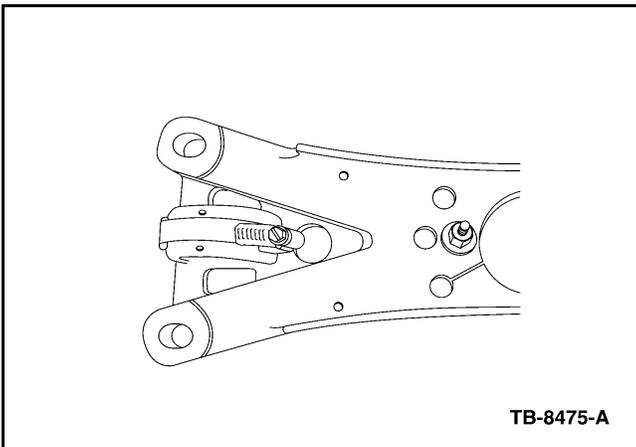
The rattle/noise may be caused by one or both of the exhaust hanger isolators on the trans cross member (number 3 cross member) being loose. To determine if an isolator is loose refer to the Service Procedure.

1. Lightly tap the exhaust hanger isolator located on the transmission crossmember (number 3) with a dead-blow hammer. It should have a solid sound to it.
2. If the hanger has a solid sound to it, do not continue with this TSB and continue with normal diagnostics.
3. If it rattles, secure it with a screw type worm clamp. Use a 3 inch, size 40 stainless worm clamp (obtain locally). Positioned 90 degrees to the exhaust hanger rod. (Figures 1-4). The clamp can be installed without removing the crossmember.

3 INCH, SIZE 40 STAINLESS WORM CLAMPS OR EQUIVALENT SHOULD BE INSTALLED WITH THE SCREW HEAD LOCATED AT EITHER THE 3 OR 9 O'CLOCK POSITION TO MAXIMIZE GROUND CLEARANCE.
