## **Engine - MIL ON/DTC's P2000-P2008/P2015/P2020 Set**

TSB 06-7-10

MIL ON WITH DTC P2004 THROUGH P2008, P151A,  
P2015, P2020 - 4.6L 3V

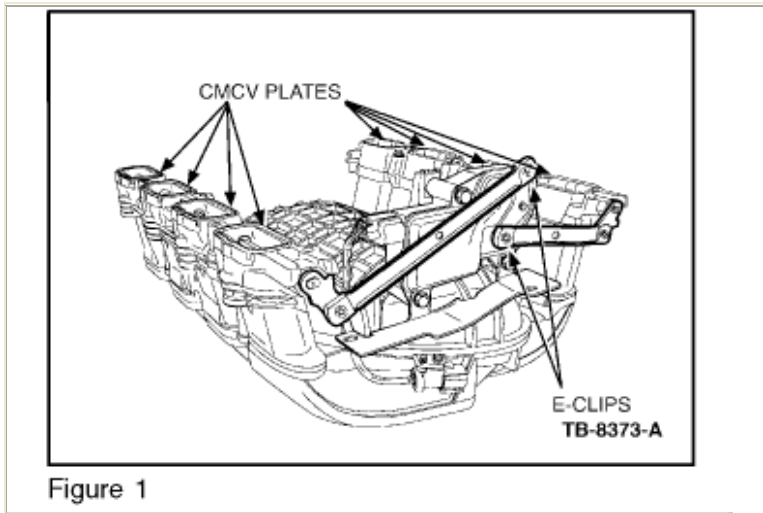
3. Disconnect the CMCV linkages from actuator motor by removing the two (2) clips (Figure 1). Discard clips.
4. Rotate each CMCV shaft (right hand and left hand) by hand, to verify that the system does not stick or bind. The shafts should rotate freely and any sticking or binding will require replacement of the entire [intake manifold](#).
5. If the components inspected in Steps 1, 2, and 3 are OK, then replace CMCV actuator motor by following procedure included in the service kit.
