**AIR BAG WARNING LAMP ON—DTC 2295 IN
RESTRAINTS CONTROL MODULE AND LAMP FLASH
CODE 22—BUILT 3/1/2007- 4/15/2007**

TSB 07-10-3

FORD:
2007 Mustang

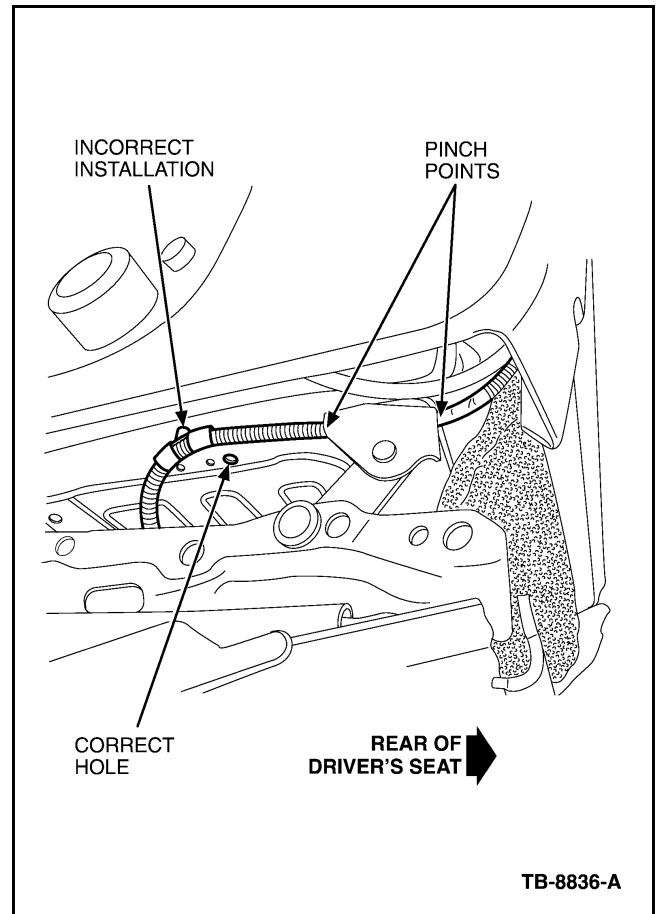
Figure 1 - Article 07-10-3

Some 2007 Mustang vehicles equipped with side air bags and built between 3/1/2007 and 4/15/2007 may exhibit an air bag light on with diagnostic trouble code (DTC) B2295 in the restraints control module with lamp flash code 22 (driver seat side air bag circuit failure). This may be caused by a pinched wire in the side air bag module wire harness resulting in a short circuit to ground.

1. Place seat up-side-down on a clean surface and inspect the side airbag wire harness for indications of chafing, pinching and incorrect wire harness routing. (Figures 1 and 2)
