TSB 07-16-7

EXTERIOR DOOR HANDLE NOT FLUSH IN THE CLOSED POSITION

2005-2008 Mustang

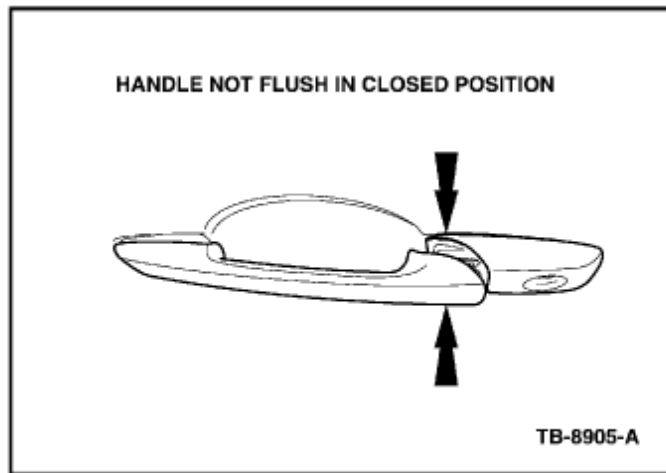
Figure 1

Some 2005-2008 Mustang vehicles may exhibit an exterior door handle not flush in the closed position. This may result in a loose handle, rattle noise, hard to open, and/or door self locks when opening outside handle. (Figure 1)

The concern is caused by pre-loading/biasing the exterior door handle actuating rod, the front door latch, or both. Follow the Service Procedure steps to correct the condition.
