## Suspension - Front Suspension Popping Noises

TSB 07-18-1

FRONT [SUSPENSION](#) POPPING NOISE WHILE  
TURNING RIGHT OR LEFT - VEHICLES BUILT  
BEFORE 4/8/2005

FORD:  
2005 Mustang

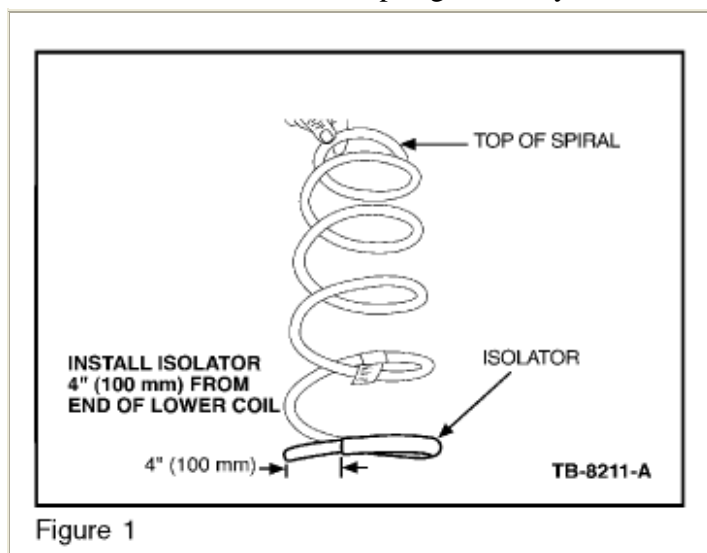
Figure 1

Some 2005 Mustang vehicles built before 4/8/2005 may exhibit an intermittent popping noise from the front of the vehicle while turning left or right. The noise will typically occur during low speed maneuvers and may occur multiple times while turning.

3. If the springs do not have a rubber isolator on the bottom spring coil, install isolators. Clean off any dirt prior to installing the isolator. The isolator should be installed 4" (100 mm) from the end of the coil (Figure 1).
