**FORD:**  
2007-2008 Mustang

### **ISSUE**

## TSB 08-9-2 (Continued)

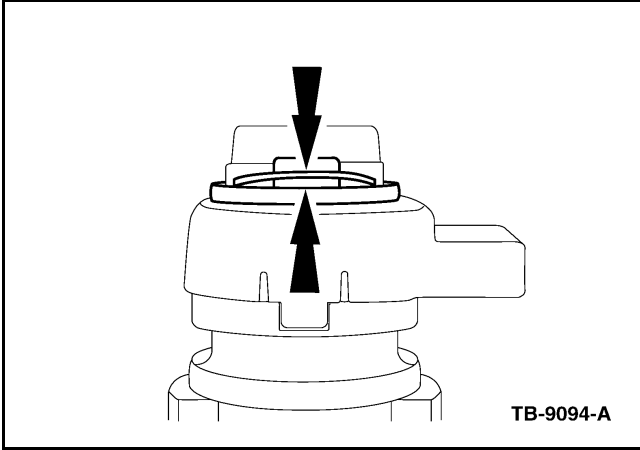
Figure 3 - Article 08-9-2

FAILURE TO PERFORM STEPS IN FIGURES 1-3 MAY RESULT IN REPEAT INTERMITTENT COMPLAINTS.

- c. E-clip must be positioned with the concave side towards the lock cylinder (upside down U) to ensure the proper tension is applied toward connection. (Figure 3)
