# INOPERATIVE RKE TRANSMITTER (KEY FOB)— DISCHARGED KEY FOB BATTERY

TSB 08-12-9

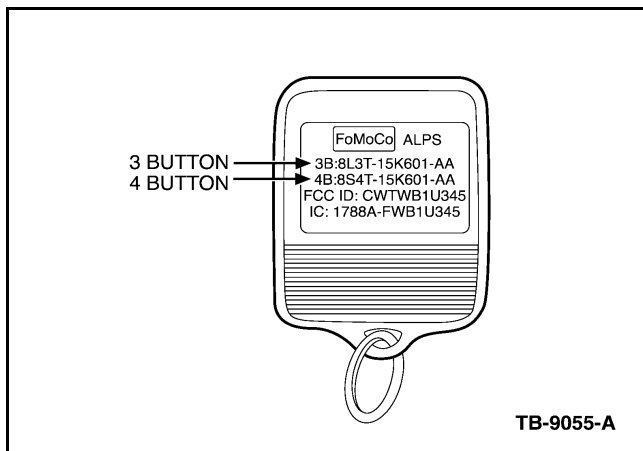
Figure 2 - Article 08-12-9

- a. If the vehicle was built within the date range, then continue with this procedure.
  - b. If not, then do not proceed. Continue with normal diagnostics per WSM, Section 501-14.
2. Is the vehicle Key Fob part number 8L3T-15K601-AA (3 button) or 8S4T-15K601-AA (4 button)? (Figure 2)
- a. Yes - Go to Step 3.
  - b. No - Do not proceed. Continue with normal diagnostics per WSM, Section 501-14.
3. Using a thin coin, open the Key Fob and inspect manufacturer's date code sticker. The first three digits = day of year. The last digit = year. (Figure 3)

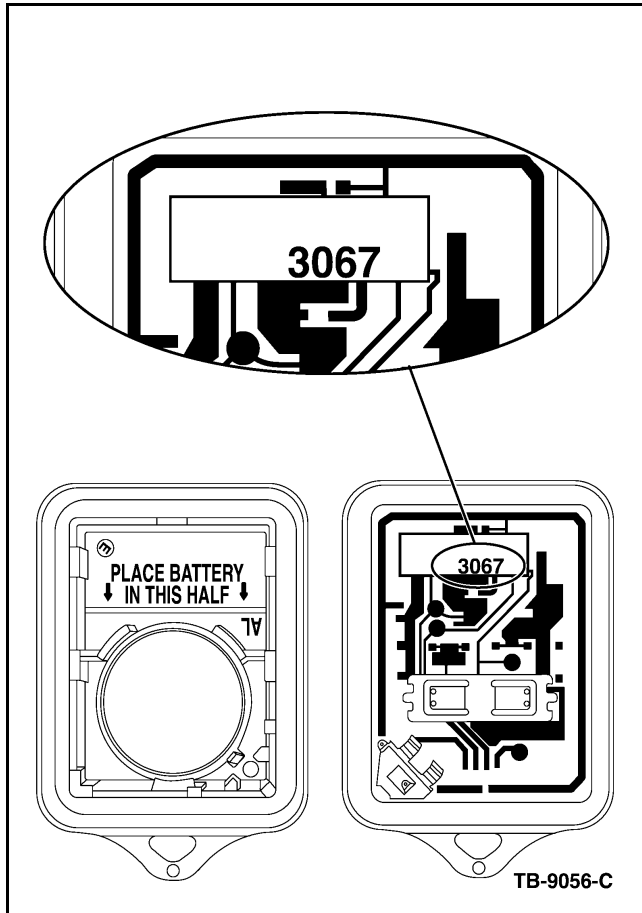
Figure 3 - Article 08-12-9

- a. If the first 3 digits are equal to or between 005 and 306 (5th day through 306th day) and the last digit is 7 (year), then proceed to Step 4.
  - b. If the number is outside this specified range, then do not proceed. Continue with normal diagnostics per WSM, Section 501-14.
4. If the Key Fob is inoperative due to a discharged Key Fob battery, and the date code falls within the specified range, then replace Key Fob. Program the new Key Fob transmitter using the IDS RKE Transmitter Programming Procedure. Reassemble old Key Fob for warranty return analysis.
