FORD:
2005-2009 Mustang

TSB 08-17-3 (Continued)

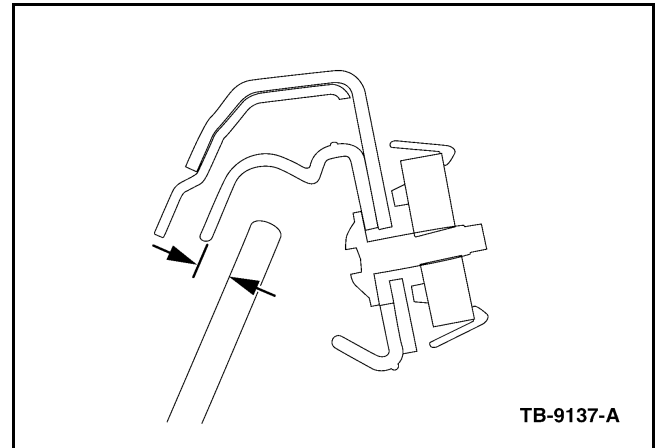
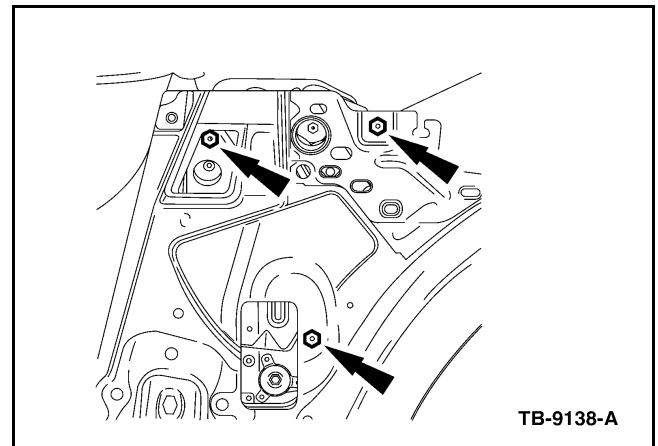
Some 2005-2009 Mustang convertible vehicles may exhibit a torn / separating quarter glass division bar due to misalignment between the front door window glass and the rear quarter window glass. Concern may be duplicated with convertible top down, quarter glass down and front door glass up. When the rear glass is raised, it may catch on the front door glass creating a scissor effect over time. The windows need to be aligned to each other and the convertible top, as a glass system.

1. Replace the quarter glass assembly, the seal is not serviced separately. Refer to Workshop Manual (WSM), Section 501-11.
2. With the convertible top closed, remove the rear side rail weather strip and close the rear quarter glass window. Adjust the quarter glass so that a $5/32'' - 3/16''$ (4-5 mm) gap exists between the glass and the convertible top weatherstrip retainer. Use the quarter glass jack screws to adjust inboard / outboard. Loosen nut. Use a 4 mm hex drive to wind the jack screw as needed. Tighten nuts. (Figures 1 and 2)

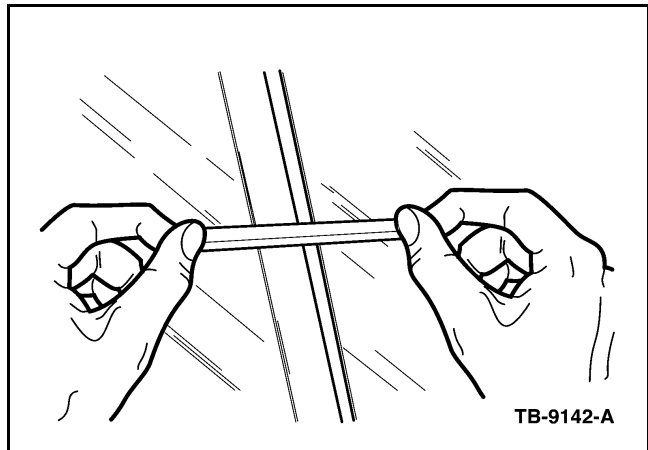
Figure 6 - Article 08-17-3

MISALIGNED DOOR GLASS WILL BOUNCE BACK DURING OPERATION IF IT CONTACTS THE INBOARD SIDE OF THE UPPER CONVERTIBLE SEAL RETAINER. CONCERN MAY BE DUPLICATED WITH TOP UP AND REAR WINDOWS DOWN. DOOR GLASS MUST BE ALIGNED TO BOTH THE CONVERTIBLE TOP AND QUARTER GLASS DIVISION BAR.

5. Adjust the door glass so that the door glass is flush to the quarter glass division bar or outboard of the division bar by no more than 1/16" (2 mm). (Figure 6). Use the door glass window regulator jack screw to adjust glass outboard. Remove the round reflector located at the bottom of the door trim panel. Turning the jack screw clockwise tips the glass outboard, counterclockwise tips the glass inward. If additional adjustment is needed, then remove trim panel and use glass clamps. Refer to WSM, Section 501-11.
