**FORD:**

**ISSUE**

The Sync Accessory Protocol Interface Module (APIM) may require updates to add system enhancements, improve system reliability or address consumer issues. The installation or availability of these updates may be made available in two different methods:

## TSB 08-21-2 (Continued)

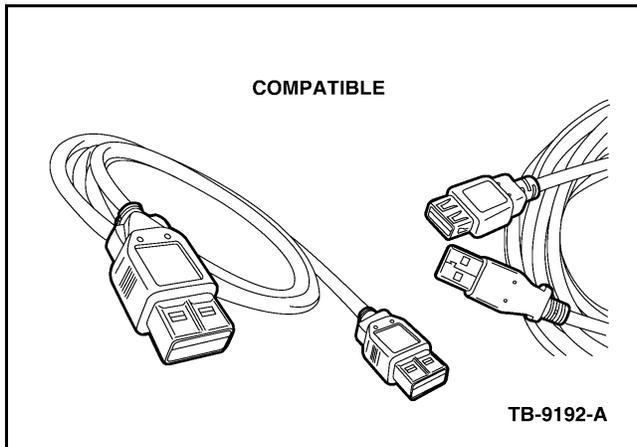
Figure 1 - Article 08-21-2

1. Turn the ignition key to the On position.
2. Turn the audio control module (ACM) on.
3. Connect the scan tool to the data link connector (DLC).
4. Connect one end of the USB male-A to male-A cable Rotunda part number CCMUSB2-AM-AM-10 (1-800-Rotunda option 6) or equivalent to the scan tool. Compatible cables. (Figures 1) Non-compatible cables. (Figure 2)
