# SHUDDER ON ACCEL—POSSIBLE WRONG TRANS CROSSMEMBER ASSEMBLY INSTALLED (EXCLUDES GT 500)

TSB 08-23-4

2005-2009 Mustang, Mustang

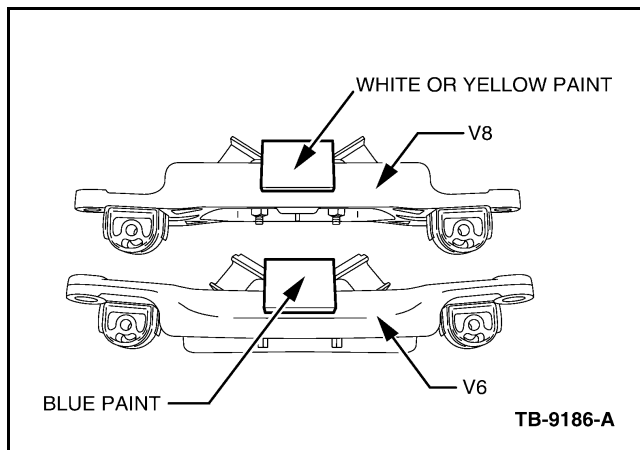
Figure 1 - Article 08-23-4

1. Inspect the transmission crossmember assembly orientation. (Figure 1)

- 4.6L V8 vehicles - Transmission crossmember hump should extend upward. Transmission support insulator (trans mount) should have a white or yellow paint dot.

- 4.0L V6 vehicles - Transmission crossmember hump should extend downward. Transmission support insulator (trans mount) should have a blue paint dot.

EXHAUST MOUNTS AND ISOLATORS, SHOWN IN FIGURE 1, WERE PRODUCTION ASSEMBLY AIDS AND ARE NOT REQUIRED. THEY WERE DELETED ON VEHICLES BUILT AFTER 12/03/2007 AND MAY HAVE ALREADY BEEN REMOVED PER TSB 08-3-4.

2. If the vehicle is found to have the wrong transmission crossmember, then remove the transmission crossmember per Workshop Manual (WSM), Section 502-00.
3. Remove the transmission support insulator (transmission mount) from the transmission crossmember.
4. If present, remove and discard exhaust mounts and isolators from the transmission crossmember. The transmission crossmember exhaust mounts and isolators are a production assembly aid and are not required. Do not cut off the hanger rod from the exhaust system.
5. Orient the original transmission crossmember to match engine. (Figure 1)
6. Install new engine-specific transmission support insulator (transmission mount) onto transmission crossmember. (Figure 1)
7. Torque transmission support insulator (trans mount) nuts to 52 lb-ft (70 N•m).
8. Install the transmission crossmember per WSM, Section 502-00.
