**FORD:**  
2005-2009 Mustang

**ISSUE**

**TSB 08-24-10 (Continued)**

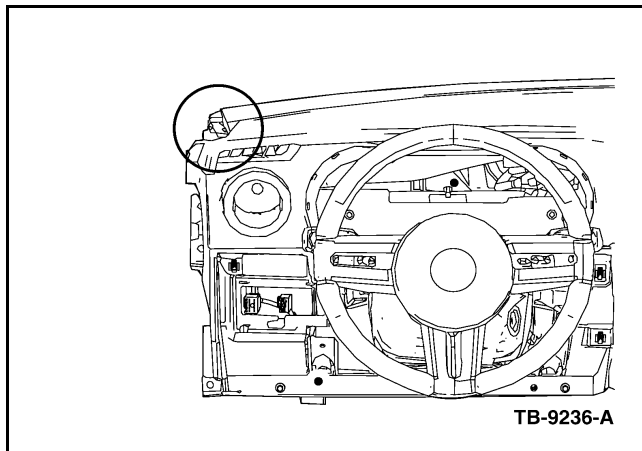
Figure 1 - Article 08-24-10

DASH INSULATOR WAS EXTENDED UNDER THIS AREA FOR 2008 AND 2009 VEHICLES. (FIGURE 1) FOR 2005-2007 VEHICLES MULTIPLE VARIETIES OF TAPE WERE USED UNDER THIS AREA. (FIGURE 2)

1. Remove A-pillar trim.
2. Inspect for tape under flanged edge of dash panel. If tape is missing or damaged, then add or replace with improved tape. This tape has a plastic top coating to protect the felt tape from wear. Install felt tape with adhesive side down. (Figures 1-2)
