## 4.0L ENGINE BELT SQUEAL OR CHIRP NOISE ON COLD STARTUP

TSB 09-7-7

2009 Mustang  
2007-2008 Explorer Sport Trac, Explorer

2007-2008 Mountaineer

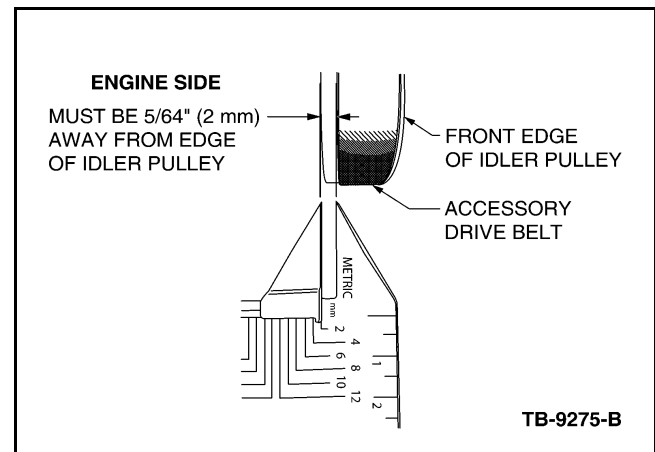
Figure 1 - Article 09-7-7

1. Visually inspect all related FEAD components for damage and or abnormal wear. Reference the online Work Shop Manual (WSM), Section 303-05. If no concerns found, proceed to Step 2.
2. Inspect for FEAD belt clearance on the idler pulley. A properly aligned belt will have an approximate  $3/32$ " (2 mm) space behind the belt on the idler pulley. (Figure 1)
3. Verify the generator bracket and idler pulley are properly seated and torqued to specification. Reference the online (WSM), Section 303-05.
  - a. If there is not an approximate  $3/32$ " (2 mm) gap, proceed with Step 3.
  - b. If there is an approximate  $3/32$ " (2 mm) gap, proceed with Step 5.
4. Replace the generator bracket with updated bracket. Reference online (WSM), Section 303-01. Proceed to Step 5.

5. Replace the accessory drive belt with the updated belt part number. Reference online (WSM), Section 303-05.
