FORD:

2007-2009 Mustang

This article supersedes TSB 7-10-3 to remove the production build date specification, update the vehicle model years and Service Procedure.

TSB 09-8-7 (Continued)

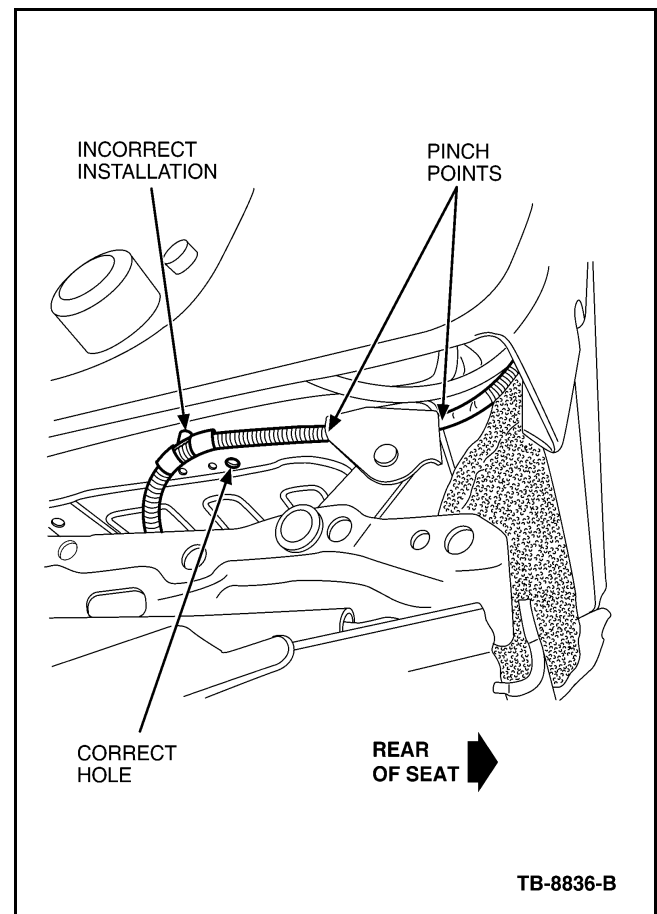
Figure 1 - Article 09-8-7

1. Place seat up-side-down on a clean surface and inspect the side airbag wire harness for indications of chafing, pinching and incorrect wire harness routing. (Figures 1 and 2)
