Seat Backrest — Front

Removal and Installation

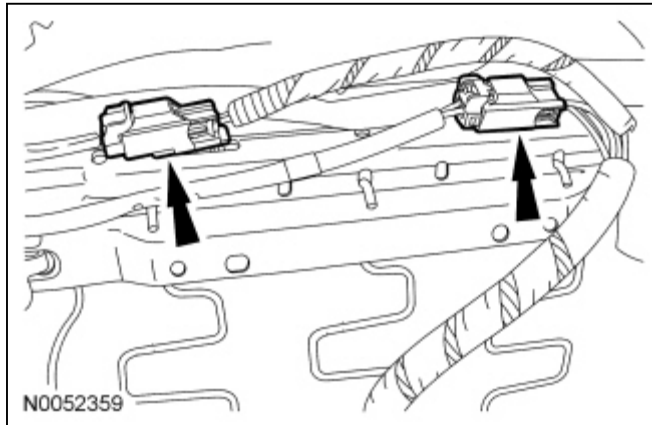
seat cushion electrical connector.

- Separate the connectors from the seat cushion frame.

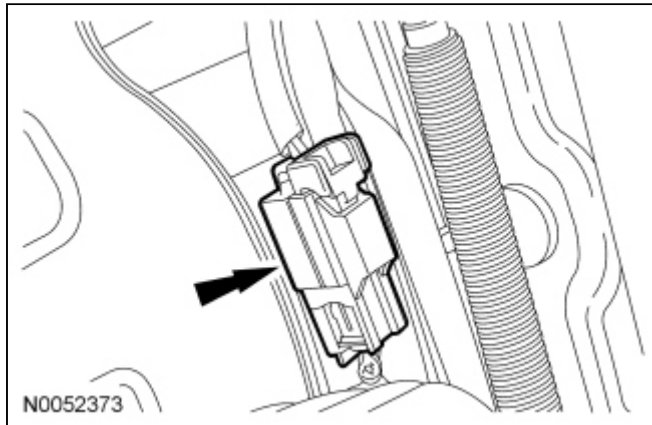
7. If equipped, disconnect the backrest heated seat electrical connector and separate it from the bottom of the seat cushion frame.

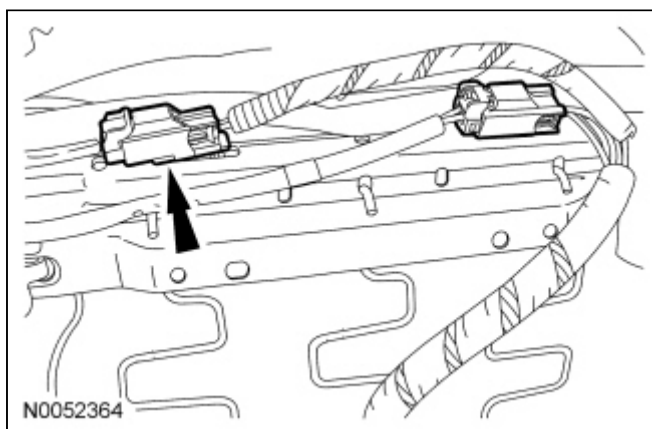
8. If equipped, release the cushion cover rear J-clip and disconnect the backrest heated seat electrical connector.
 - Detach the connector from the seat cushion frame.
