**CARPET REMOVE AND REPLACE****TSB 06-26-2**

**FORD:**  
2005-2007 Mustang

Some 2005-2007 Mustang vehicles may need to have the carpet replaced for various issues. The following procedure will allow the carpet to be removed and replaced without removing the heater / air conditioning plenum, instrument panel, or restraints control module (RCM).

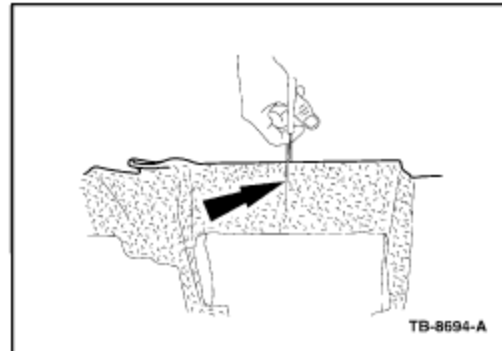
Figure 1 - Article 06-26-2

1. Using scissors, cut the new carpeting in the areas shown. (Figure 1 and Figure 2)

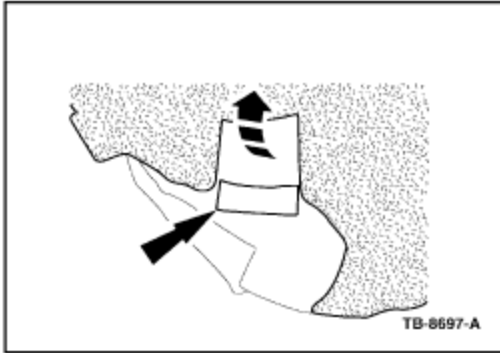
Figure 3 - Article 06-26-2

2. Clean the area using an alcohol swab or rag and then apply a thin layer of Motorcraft Trim and Weatherstrip Adhesive on the carpet backing. (Figure 3 and Figure 4) Allow to dry for 5 minutes.

3. Apply a 3" by 1" strip of self adhesive Velcro (both halves-obtain locally) to the areas shown. (Figures 3 and 4)
