FORD:

2005-2008 Mustang 2004-2008 F-150 2005-2008 Expedition, F-Super Duty 2006-2008 Explorer, F-53 Motorhome Chassis 2007-2008 Explorer Sport Trac

This article supersedes TSB **08-1-9** to update Vehicle Applications, Service Procedure and Part List.

TSB 08-7-6 (Continued)

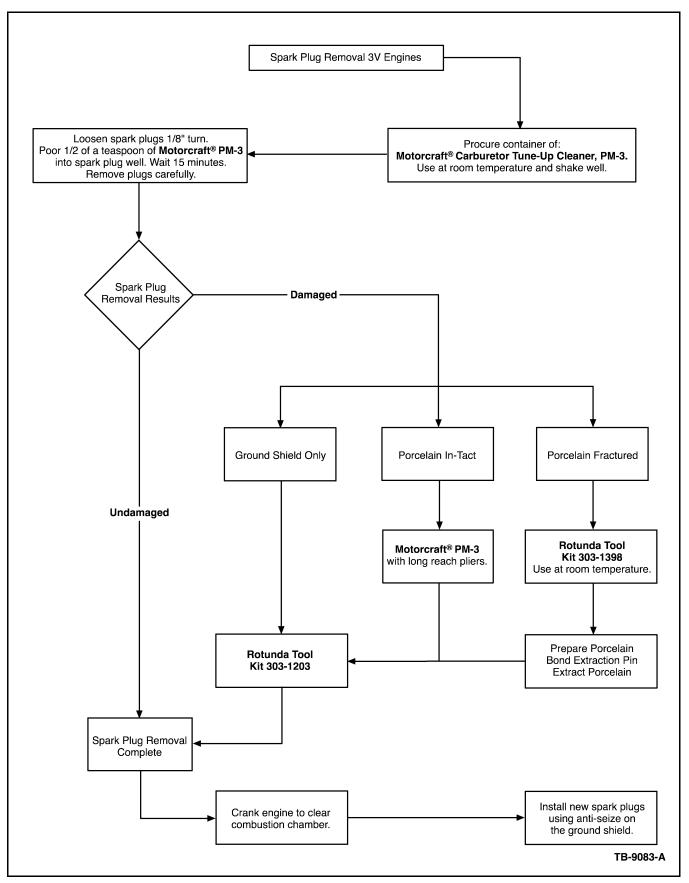
Figure 5 - Article 08-7-6

Flowchart of procedure. (Figure 5)

If the spark plug separates after following the Spark Plug Removal Procedure, it will fail in one of three modes. Refer to the appropriate removal procedure as required.

a. Mode 1: The ground electrode shield is left behind as an empty shell. (Figure 2)

b. Mode 2: The entire porcelain insulator and ground electrode shield remains in the cylinder head. (Figure 3)

c. Mode 3: The upper section of porcelain broke off with remaining porcelain left inside the ground shield. (Figure 4)

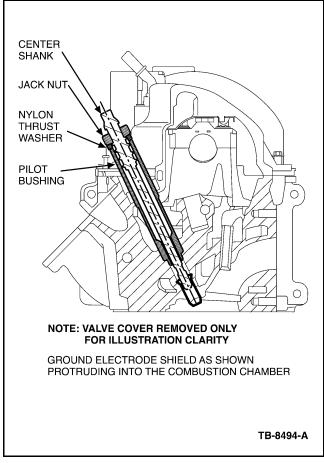
Figure 9 - Article 08-7-6

4. Thread Rotunda special service tool 303-1203 into the ground electrode shield. (Figure 9)

- a. Install the stepped end of the tool pilot bushing into the spark plug well ensuring it bottoms out.
- Screw the center shank into the ground electrode shield. Do not over tighten the shank, to prevent thread stripping.
- c. Install the nylon washer and jack nut until finger tight.
- d. Turn the jack nut until the ground electrode is freed from the cavity and withdraw the tool assembly.

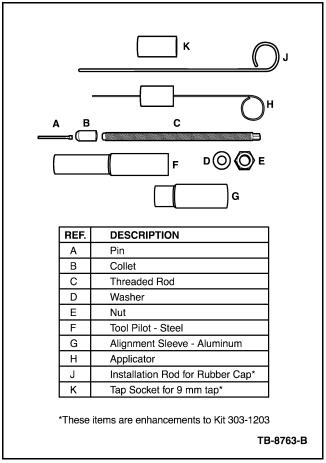
Figure 10 - Article 08-7-6

Use Rotunda special service tool kit 303-1398 to remove porcelain broken inside the ground electrode shield. (FIGURE 10)

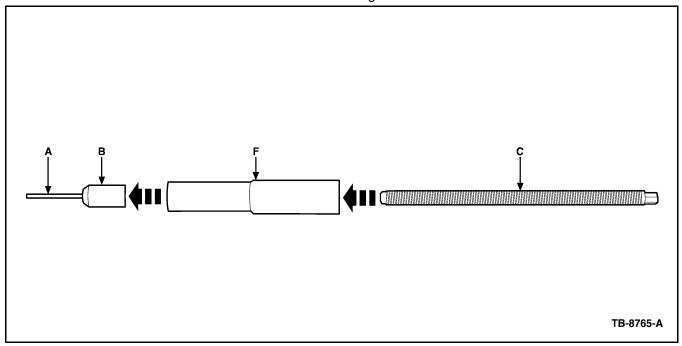
Figure 12 - Article 08-7-6

- 1. Remove any remaining electrode material from broken porcelain with long nose reach pliers.
- Spray Motorcraft® Metal Brake Parts Cleaner into the porcelain hole for 2-4 seconds using the straw nozzle supplied with the brake cleaner can.
- 3. Insert a pin (A) into the collet (B). Screw the collet onto the threaded rod (C). Install the assembled collet, pin, and threaded rod into the steel tool pilot (F). (Figures 11 and 12)

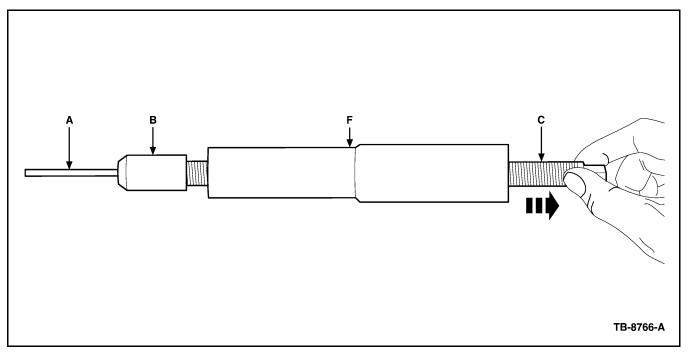
Figure 13 - Article 08-7-6

4. Retract the collet and pin into the steel tool pilot, protecting the pin. (Figures 13 and 14)

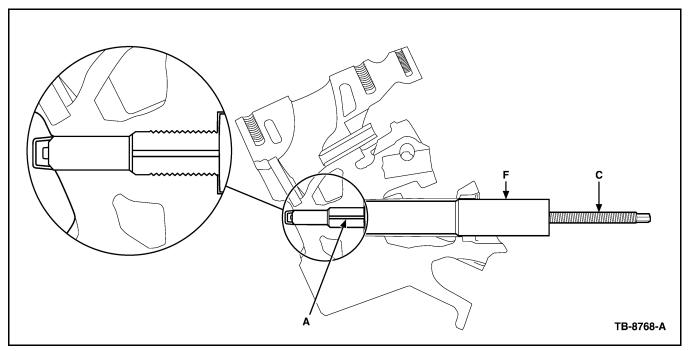
Figure 15 - Article 08-7-6

5. Insert the completed assembly into the spark plug well and fully engage the pin into the porcelain. (Figure 15)

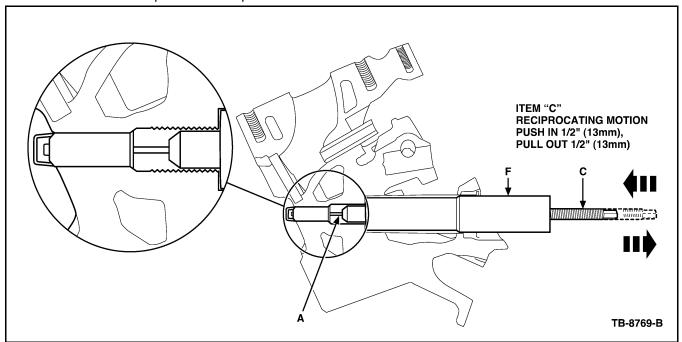
Figure 16 - Article 08-7-6

- 6. Spray Motorcraft® Metal Brake Parts Cleaner 2-4 seconds between the spark plug well and steel tool pilot. The steel tool pilot must be lifted up approximately 1/2" to allow brake cleaner to flood the porcelain and pin.
- Scrub the porcelain inside diameter by moving the threaded rod up and down vigorously. Take care making sure the pin does not disengage the porcelain. (Figure 16).

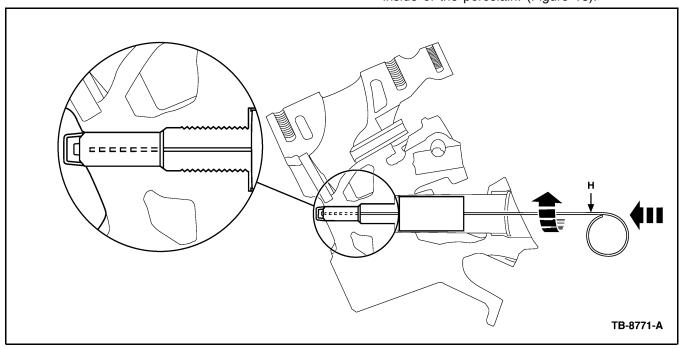
Figure 18 - Article 08-7-6

Insert applicator into the porcelain and move applicator up and down 1/2" (13 mm) while turning to spread the Loctite® 638™ on the inside of the porcelain. (Figure 18).

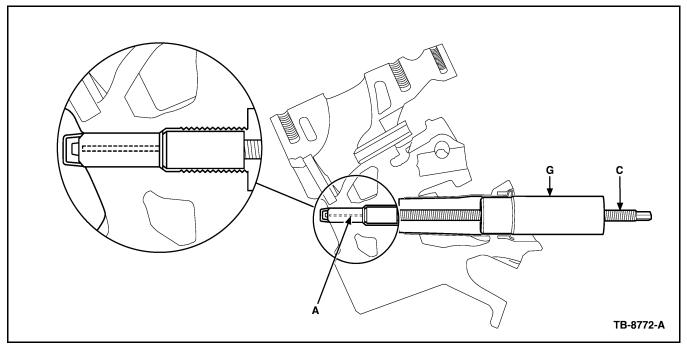
Figure 19 - Article 08-7-6

- Insert the completed assembly into spark plug well and fully engage the pin into the porcelain with a twisting motion to spread the bonding agent.
- Add additional Loctite® 638[™], repeating Steps 6-8.
- 10. Leave the pin fully inserted in the porcelain while the adhesive cures. Replace the steel tool pilot with the aluminum alignment sleeve (G), Figure 9, to support the threaded rod while the adhesive cures if additional porcelain fragments are present in other cylinders. (Figure 19).
