FORD:

2007-2009 Mustang

TSB 09-9-2 (Continued)

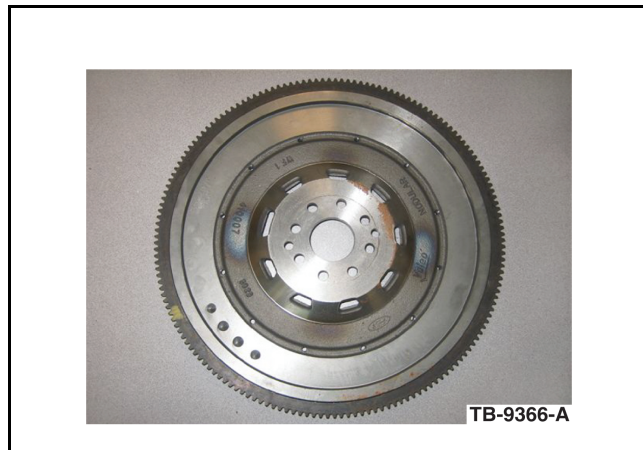
Figure 1 - Article 09-9-2

Located at the end of the procedure are Figures 1, 2 and 3 which show the typical appearance of a flywheel and clutch that has been damaged due to overheating of the clutch. Figures 4, 5 and 6 show the typical appearance of a good flywheel and clutch.

1. Remove, drain, disassemble and clean the transmission per Workshop Manual (WSM), Section 308-03C.
2. Remove and replace input shaft and all synchronizer assemblies per WSM, Section 308-03C.
3. Assemble the transmission per WSM, Section 308-03C.
4. Remove clutch disc and plate assembly and pilot bearing per WSM, Section 308-01.
5. Remove and replace flywheel per WSM, Section 303-01C. Discard old bolts and use bolts provided in flywheel kit.
6. Install new pilot bearing per WSM, Section 308-01.
7. Install new clutch disc and plate assembly per online WSM, Section 308-01 (vehicles with solid design flywheel). Discard old bolts and use bolts provided in clutch kit. Tighten bolts to 89 lb-in (10 N•m) in a star pattern. Tighten an additional 90 degrees in a star pattern.
